Help Sheet 1

RF Feedback

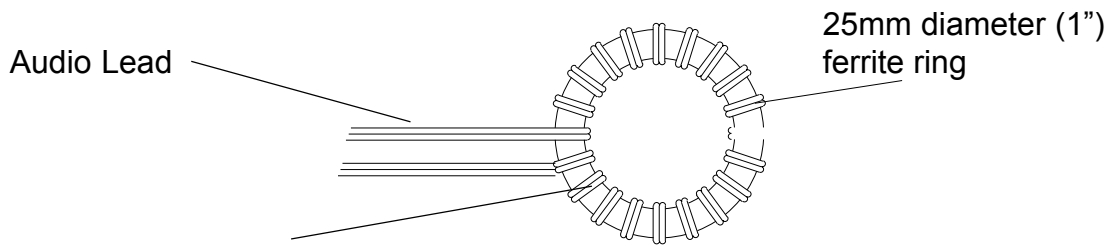
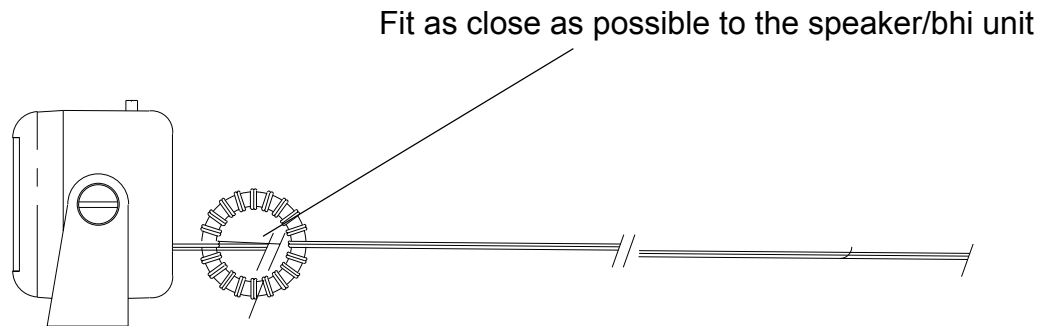
Figure 1.
Ferrite ring winding detail

All bhi products will operate correctly under normal working conditions. However if problems with feedback are experienced during transmission then the following help sheet has been prepared to help resolve this problem. Check out the other FAQ's for this issue.

Wind as many turns as possible around the ferrite

Try transmitting again. If the problem persists , then move to step 2.
